Manhole Inspection Summary

Manhole # S35II_014MH

Insp Date: **3/15/07 10:13 AM**

Location Address: **1500 LATROBE ST**

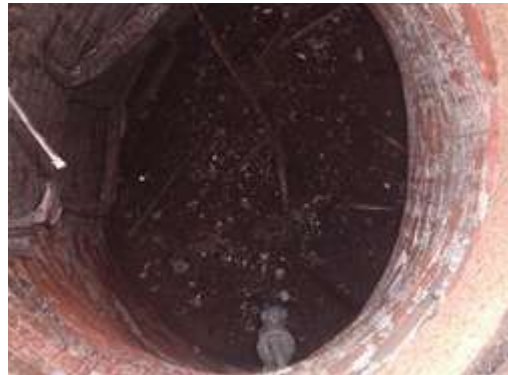
Top View

Corroded steps. Channel debris. Valve.

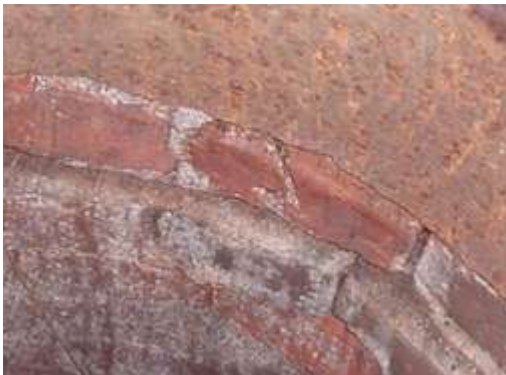
Defect

Adjustment deterioration, cracks and infiltration.

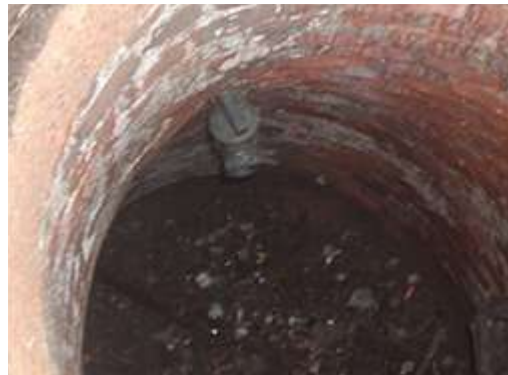
Defect

Adjustment and Barrel infiltration.

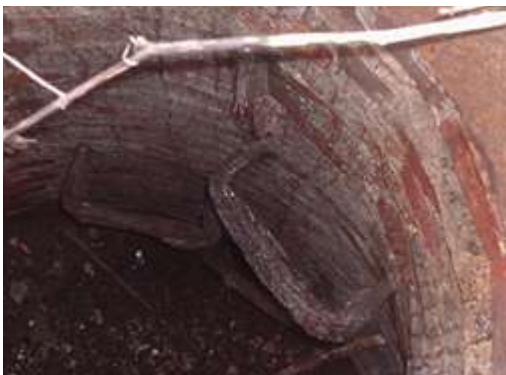
Defect

Adjustment infiltration.

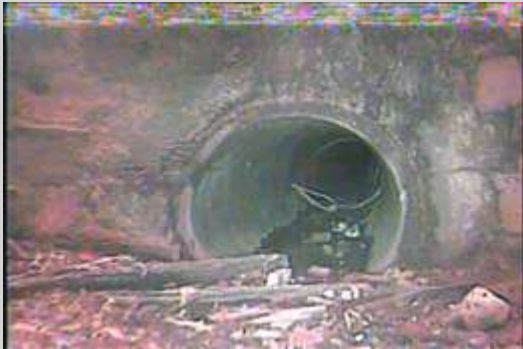
8 in. Circular Gravity Sewer
Pipe Out @ 12 O'Clock

Deposits: ☐ None ☒ **Mud** ☐ Sludge ☒ **Debris** ☐ Grease

Silt Depth: **0.5** (in.) Deposits Extent: **Light**
